Experimental Validation of the Seismic Performance of a Foldable Steel Unit House

Ryosuke MATSUDA

Candidate for the Degree of Master of Engineering

Division of Architectural and Structural Design

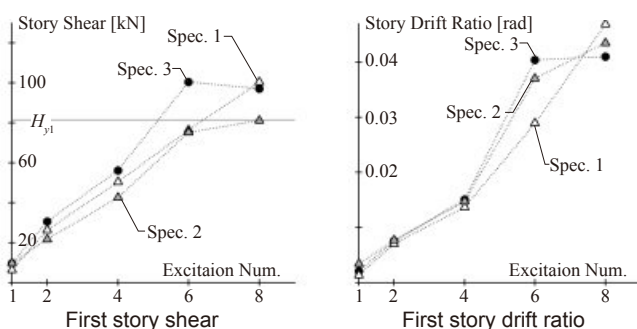
Figure 8 shows transition of maximum story shear and story drift of first story in each specimen. For the 10% to the first 100% excitation, story shear was 20% larger in Specimen 3 than in Specimen 1. This difference corresponded to the different in mass of the second floor. For the second 100% excitation, the story shear were equal between Specimens 1 and 3, presumably because they reached the strength, equal between the specimens, determined by the slip resistance of slip-critical bolted connections. The story drifts were similar in all specimens until the 50% excitation. During the second 100% excitation, all 3 specimens deformed to 0.04 rad.

Figure 8. Specimens placed on shake table
